**Attachment A: Digital Images**

August 27<sup>th</sup>, 2008

BOE Building Break Room 807/805 and 22<sup>nd</sup> and 23<sup>rd</sup> Floor Hopper Rooms Areas  
450 N Street, Sacramento, CA

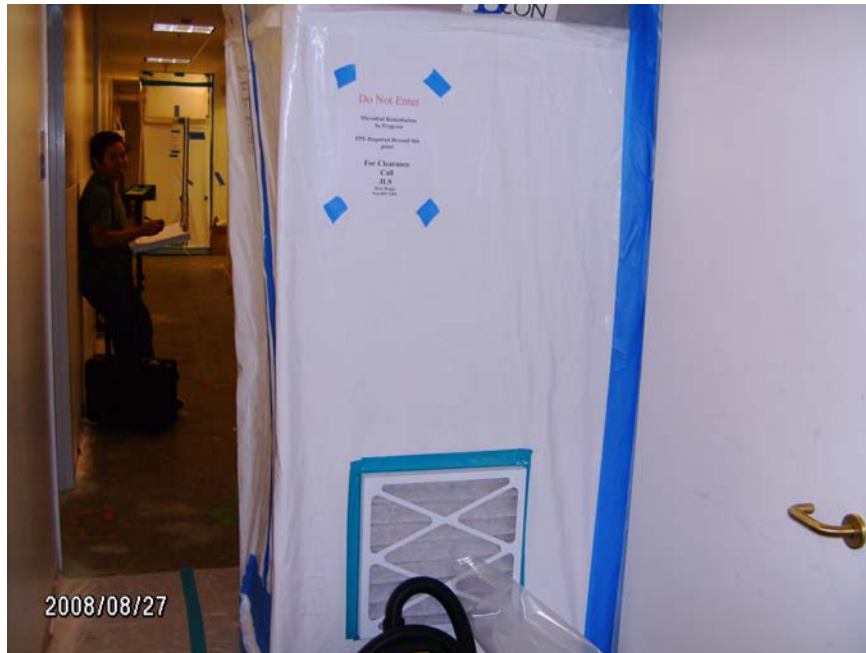
- 1) Image of hallway containment leading to 22<sup>nd</sup> Floor hopper Room area at time of assessment of BOE Building (Subject Building) located at 450 N Street, Sacramento, California.

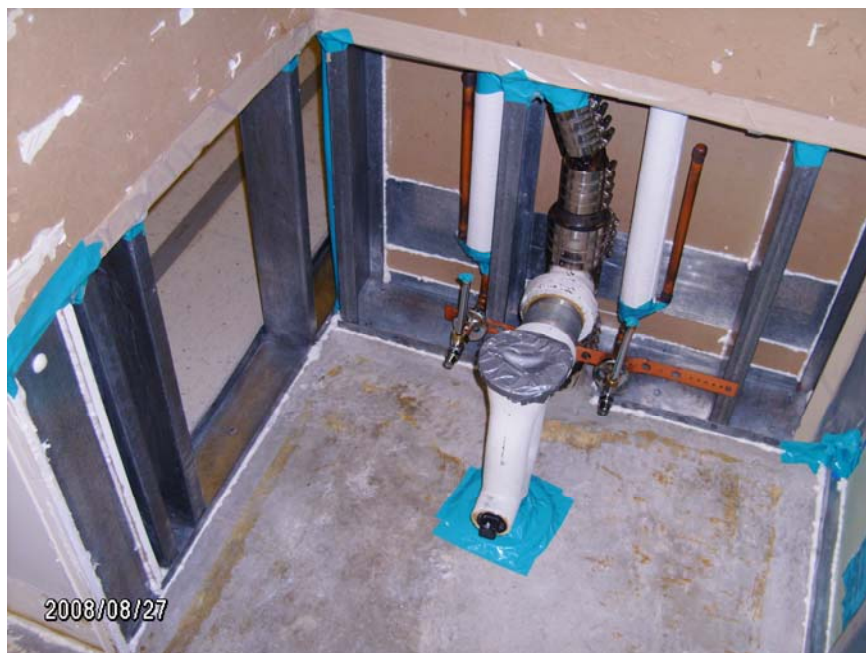
- 2) Image of area and material removal adjacent to wet-mop sink unit at time of clearance assessment.

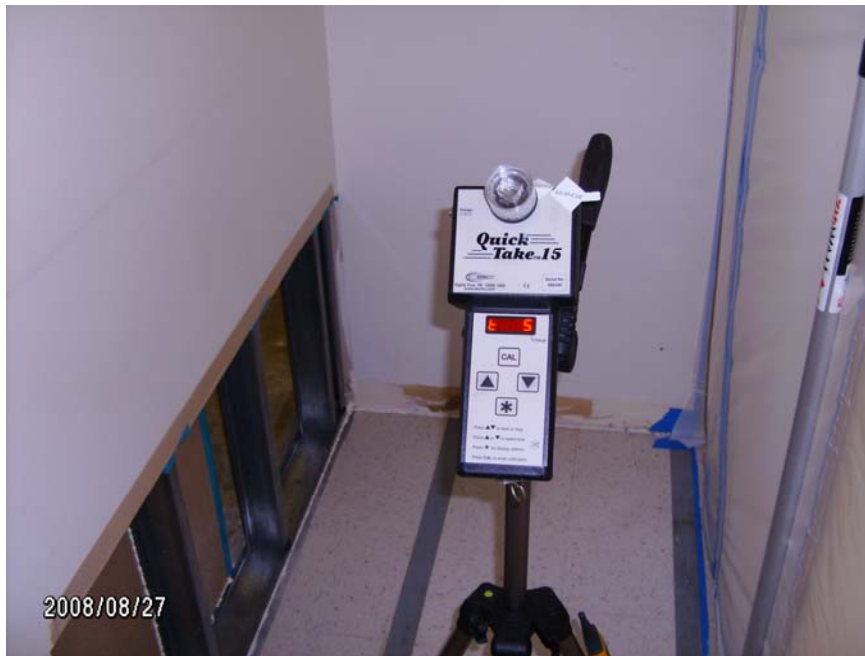
- 3) Image of air sampling equipment and wall removal within mail center room adjacent to 22<sup>nd</sup> floor Hopper Room area at time of assessment.

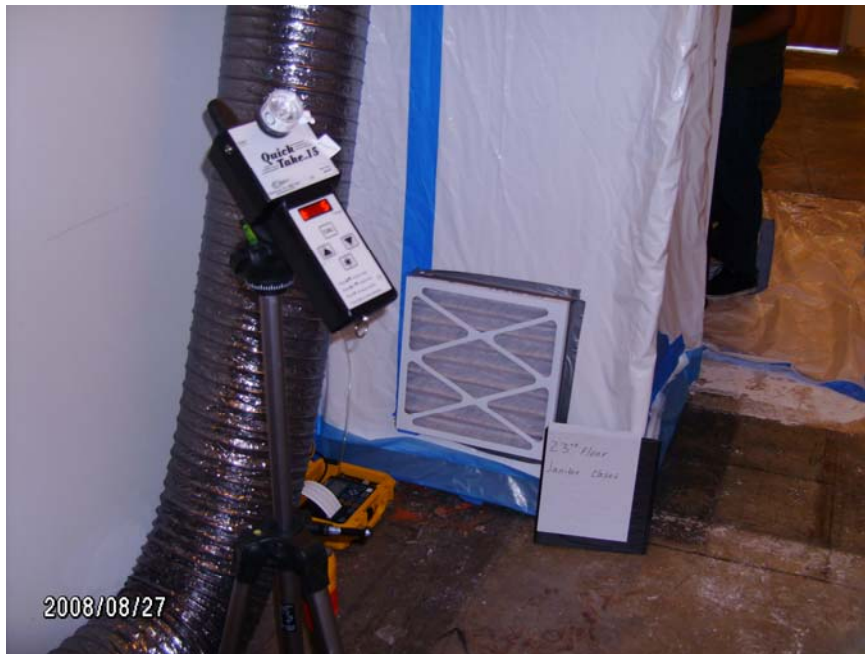
- 4) Image of air sampling equipment utilized in hallway adjacent to 23<sup>rd</sup> floor Hopper Room area at time of assessment.

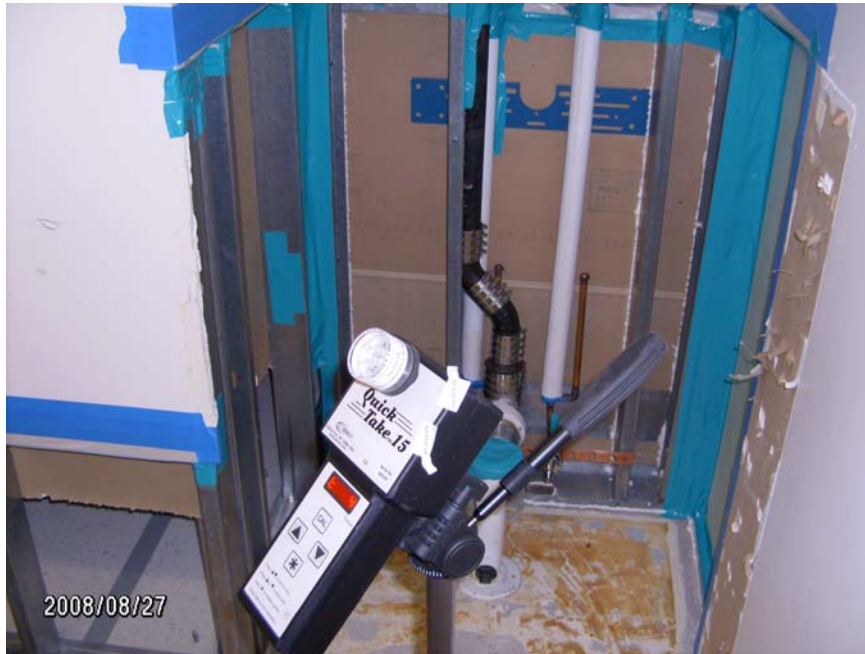
- 5) Image of air sampling equipment and area material removal adjacent to wet-mop sink unit within 23<sup>rd</sup> Floor Hopper Room at time of clearance assessment.

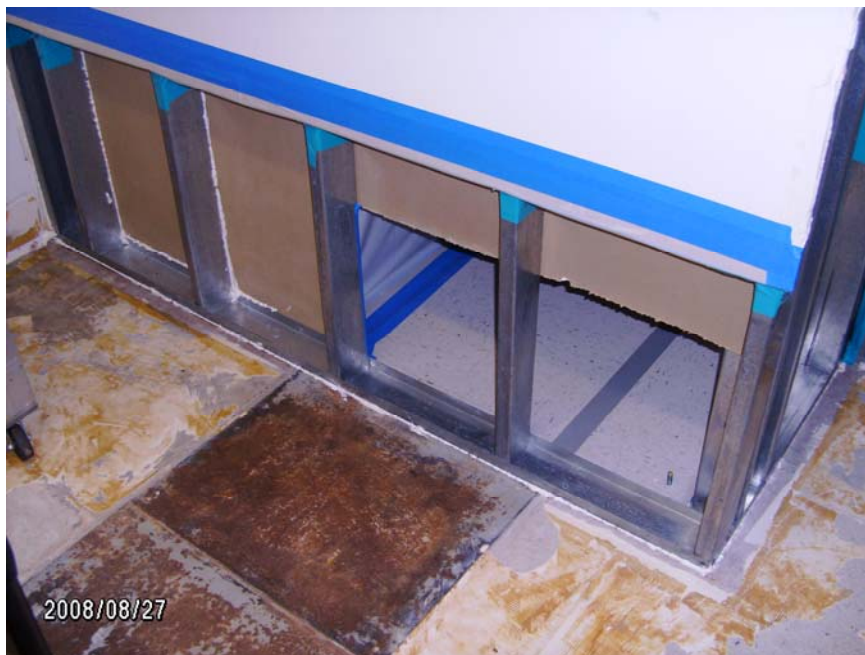
- 6) Image of wallboard removal delineation to left of wet-mop sink area within 23<sup>rd</sup> Floor Hopper Room area at time of assessment.

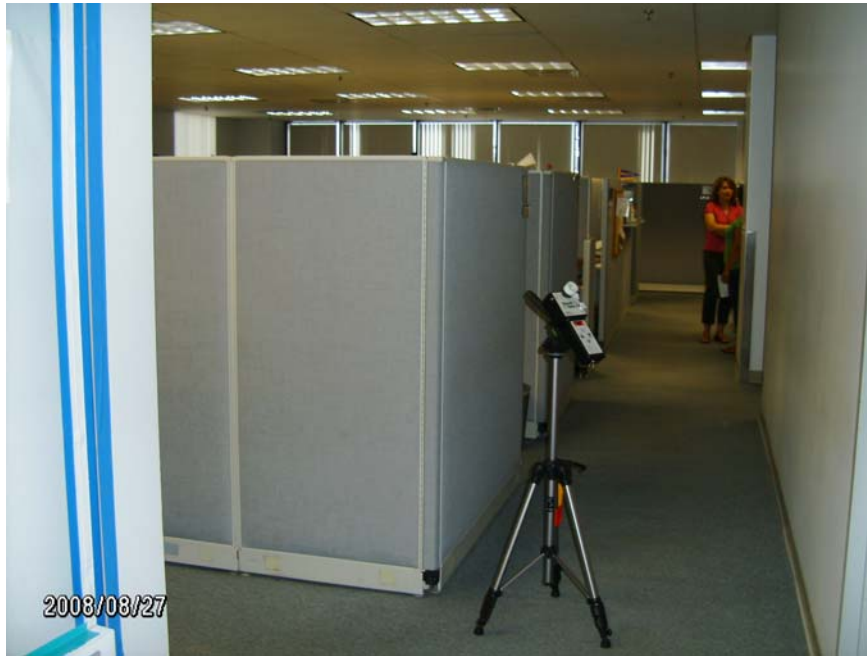
- 7) Image of air sampling performed within area occupied by BOE staff adjacent to Break room 807 at time of assessment.

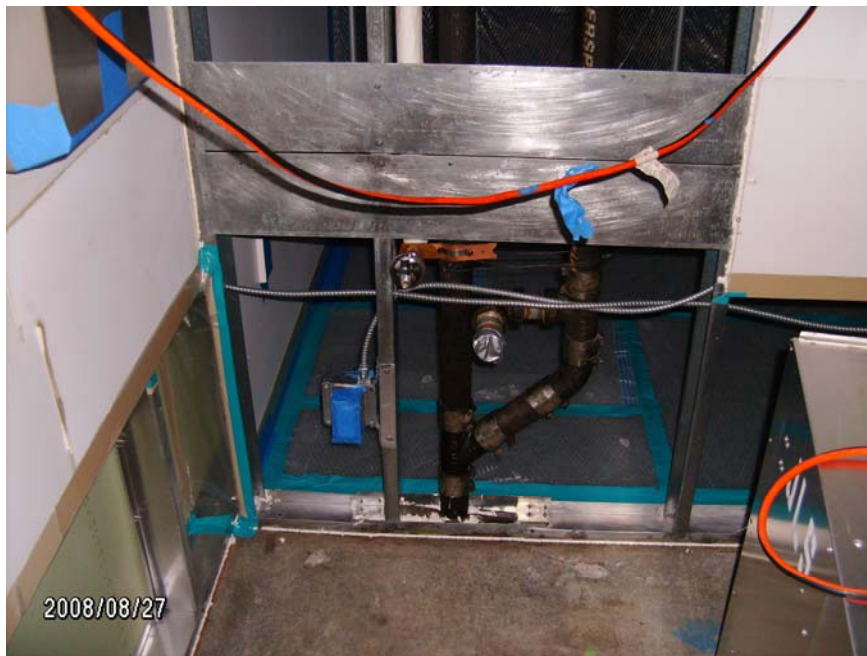
- 8) Image of material removal delineation and exposed plumbing systems within break room 807 at the time of clearance assessment activities.

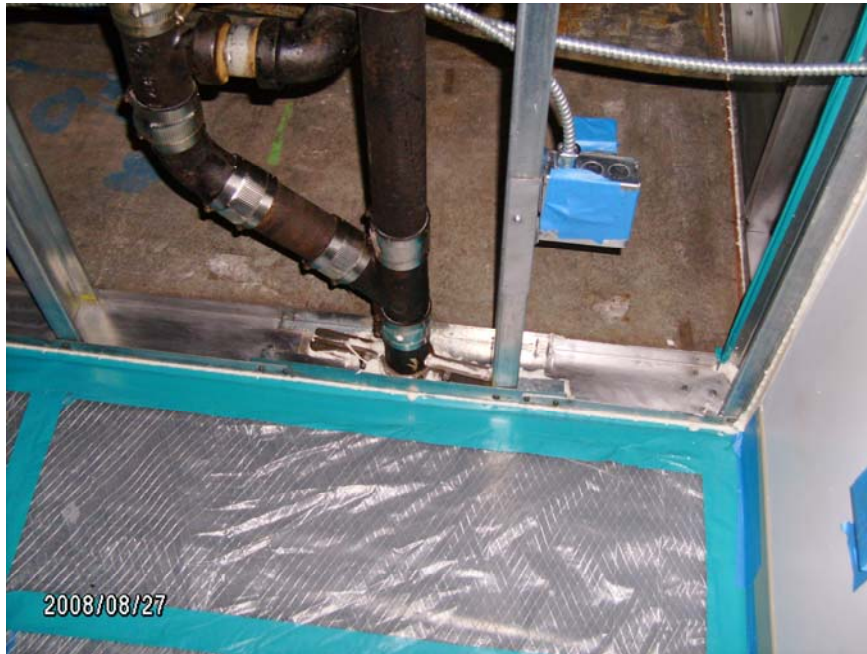
- 9) Close-up image of exposed wall cavity as viewed from Conference Room 805 at time of assessment.

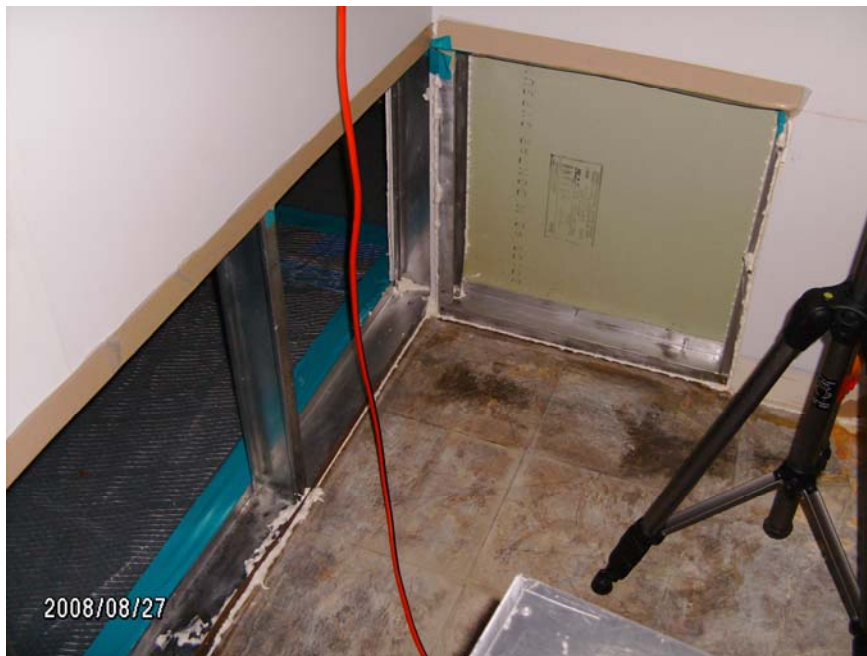
- 10) Image from 807 indicating exposed subflooring and delineation of wallboard removal at previous area at the time of assessment.
